National Transportation Safety Board
Office of Marine Safety

Group Chairman's Factual Report
Engineering and Operations

Accident Number: DCA-01-MM-022

Accident No.: DCA01MM022
Vessels Involved: USS *GREENEVILLE* & MV *EHIME MARU*
Location: About 9 miles south of Oahu, Hawaii
Date: February 9, 2001
Time: 1343 HST¹

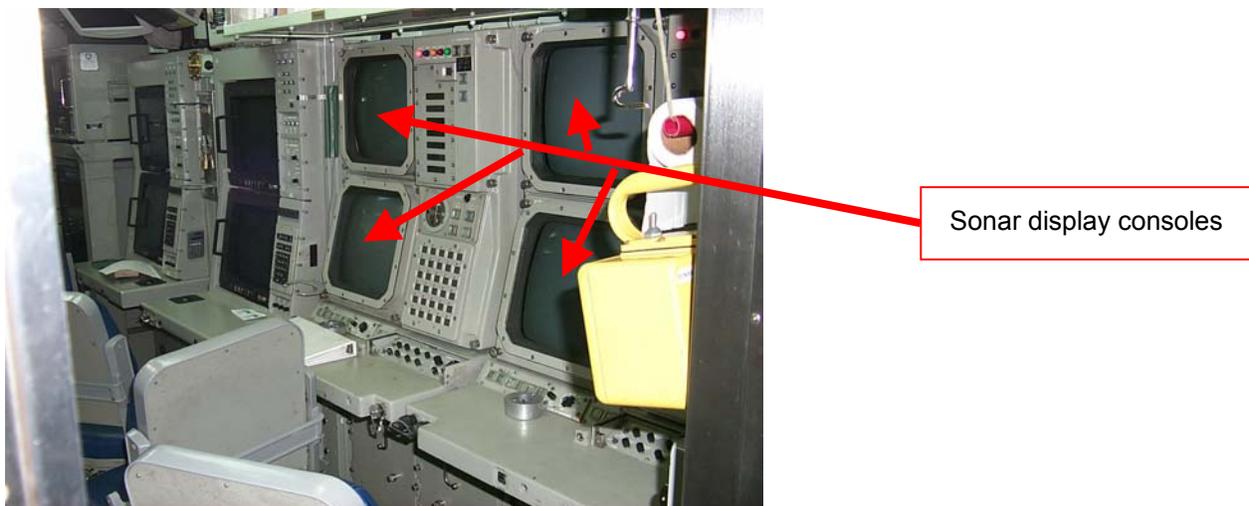
Figure 2 Sonar system consoles. Looking from right to left are the 4 CRT displays associated with the hull-mounted arrays. To the left of these displays were the towed array system displays. (U.S. Navy photo)

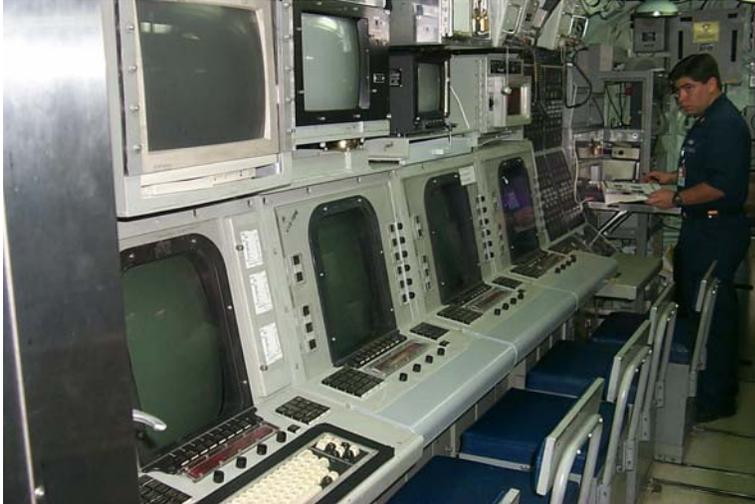
Figure 3 - Fire control display and interface consoles. (U.S. Navy photo)

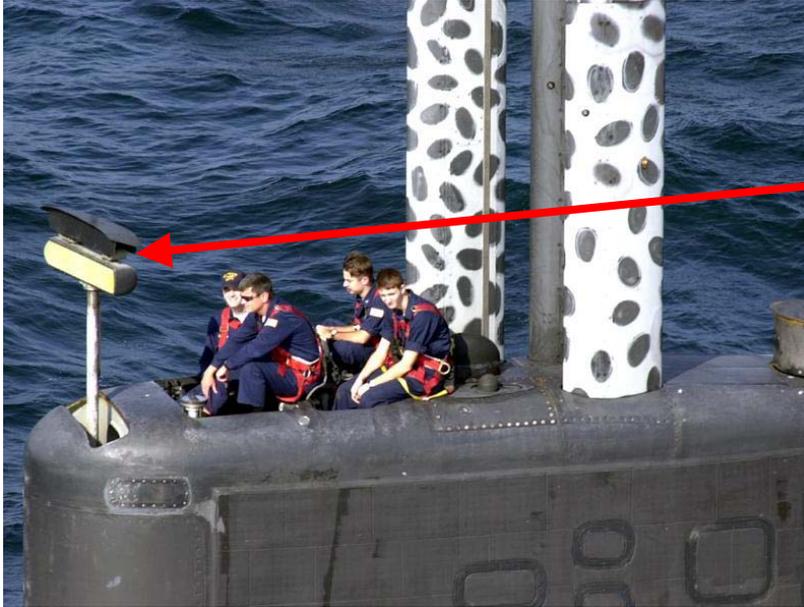
Figure 4 Main radar antenna (U.S. Navy photo)

Condition of sensors. After the accident, the Navy performed testing on the sensor systems to determine if any were in a degraded condition at the time of the accident. No significant problems with the equipment were found during the testing. In its final report, the navy's Court of Inquiry concluded that "no

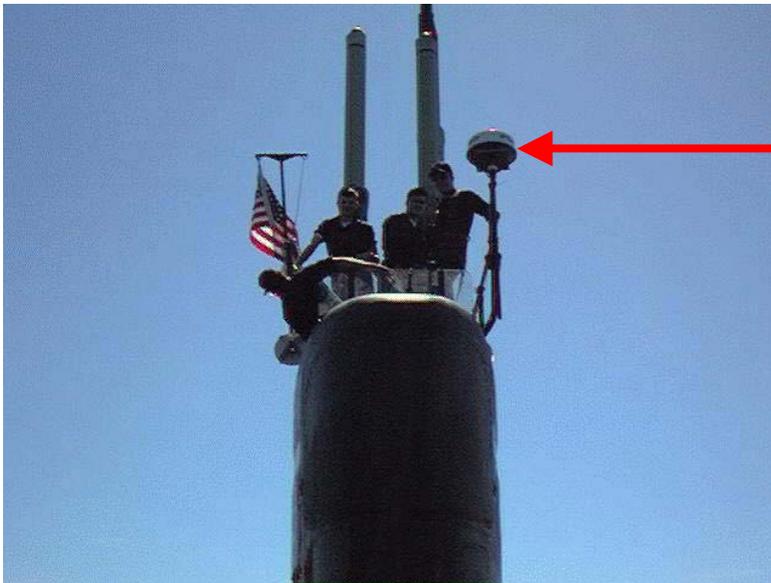
COTS radar system antenna

The antenna for COTS radar system was not permanently mounted, but rather, was portable; and its mounting required entry into the cockpit on the top of the sail (see figure 5). Both radar systems were approximately equivalent in terms of capabilities and features. On the day of the accident, the submarine's radar systems were not used to search for surface contacts.

Figure 5 Secondary radar antenna (U.S. Navy photo)

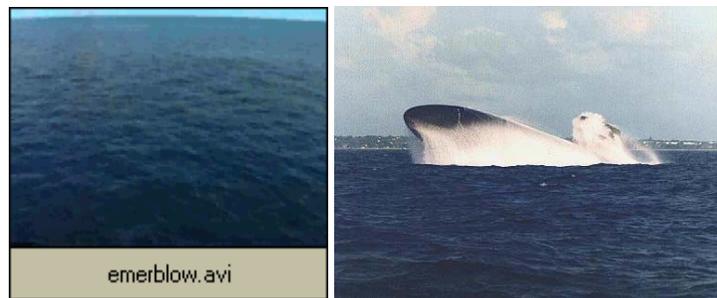
Emergency surfacing drill (EMBT blow). The emergency main ballast tank (EMBT) blow is a procedure used to quickly surface a submerged submarine in the event of a casualty that immediately threatens the safety of the submarine. The EMBT blow procedure involves the introduction of high pressure air (4500 psi) into the main ballast tanks from air receivers (storage tanks) located near the main ballast tanks. The flow of air to the ballast tanks can be quickly initiated by the activation of the levers on two pilot valves (also called “chicken switches”) located near the ballast control panel (see figure 10). The volume of air admitted to the main ballast tanks is controlled by the duration of the blow. On the day of the accident, the *Greeneville* conducted a ten-second blow EMBT blow to quickly ascend from a depth of 400 feet.¹⁰⁶

Figure 6 Video Clip (avi) - Emergency Blow (U.S. Navy video) (double click left picture to activate video)

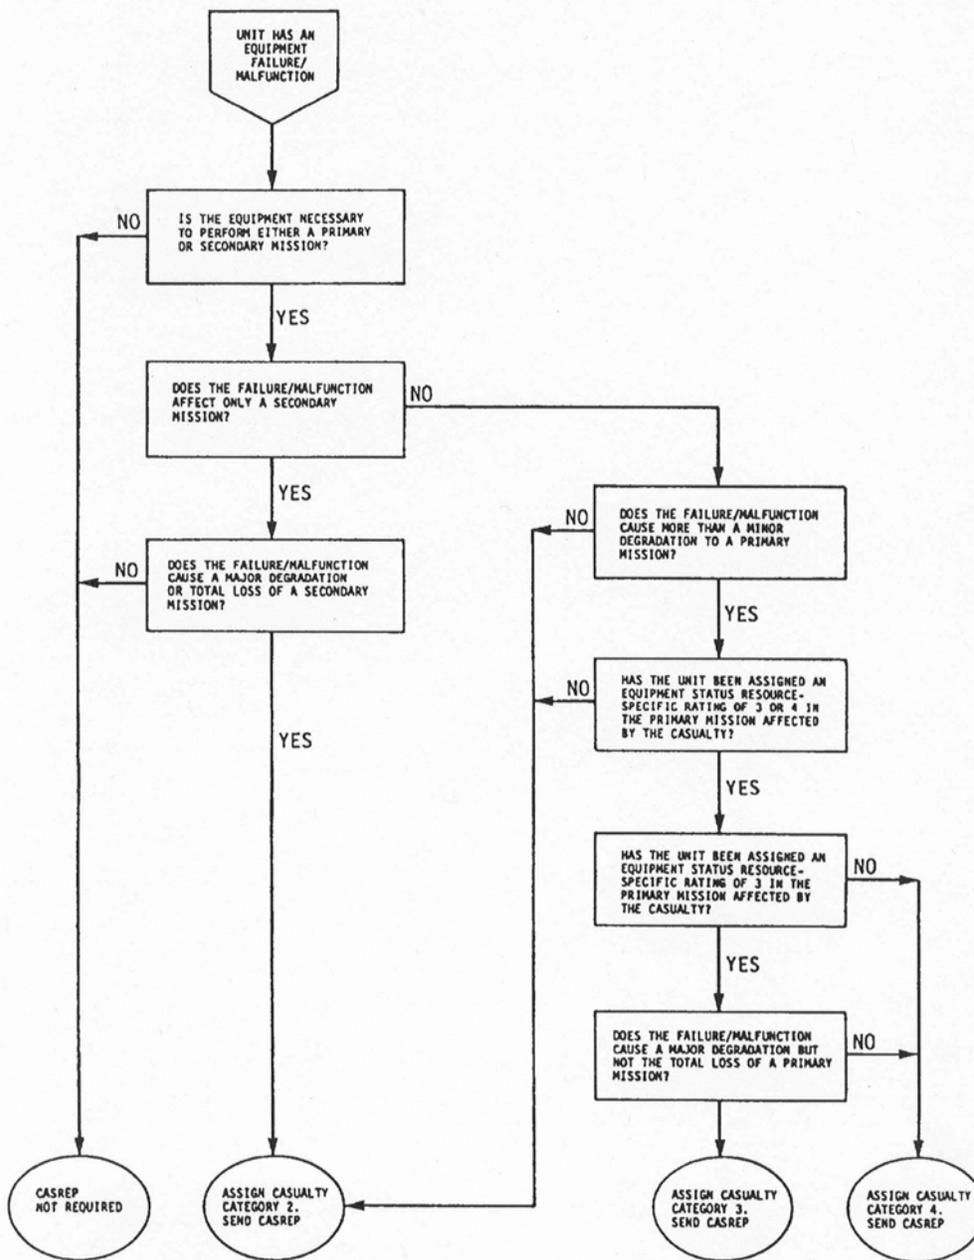
A casualty is defined as an equipment malfunction or deficiency that cannot be corrected within 48 hours and which reduces the unit's ability to perform a primary mission, or reduces the unit's ability to perform a secondary mission. (See figure 13).

Figure 9 - CASREP decision tree (U.S. Navy figure)¹¹⁸
